MSC APOLLO 13 INVESTIGATION TEAM

SPACECRAFT INCIDENT INVESTIGATION

VOLUME I ANOMALY INVESTIGATION

JUNE 1970

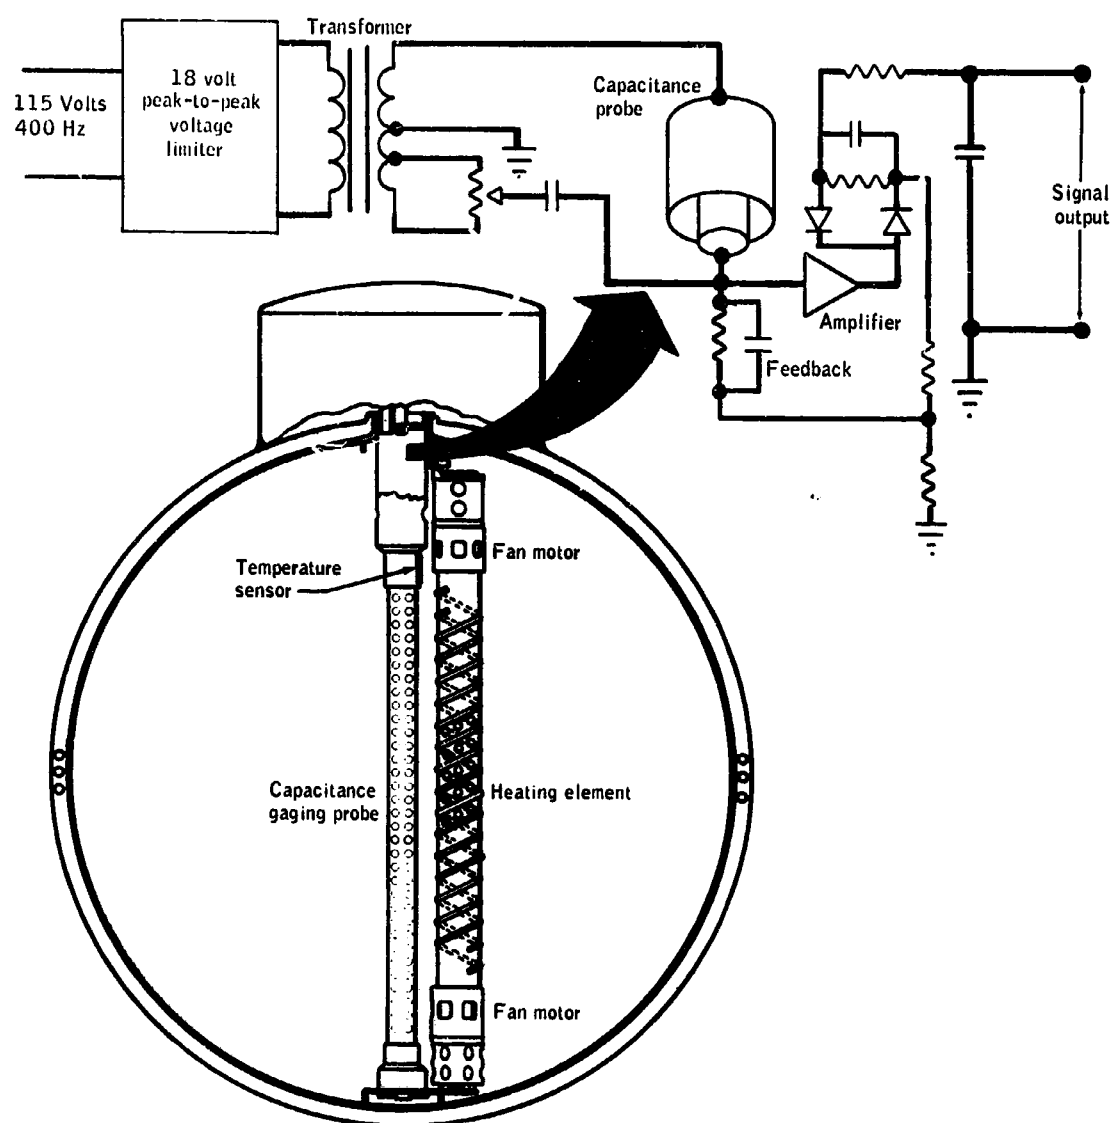
Figure 4-1.- Quantity gage.

The first anomalous inflight condition associated with the cryogenic oxygen tank 2 occurred at 46:40:06 when the ac-powered destratification fans in both cryogenic oxygen tanks were turned on. Within about 3 seconds after fan activation, the quantity measurement for cryogenic oxygen tank 2 abruptly indicated full-scale high. This system indicates density of the cryogenic oxygen by measuring its dielectric constant, which is a function of density. This instrument is a capacitor which consists of two concentric aluminum tubes inside the tank (fig. 4-1).

Tests have shown that an open-circuit in the leads to the capacitor assembly or a short across the capacitor or its leads will drive the output to full scale. If this short-circuit is removed, the output signal drops abruptly from full scale to zero, and then in about a second, it settles out to the proper reading, as noted in the data of figure 4-2. This agrees with the flight data from the quantity probe. Tests also show that if the inner tube is shorted to ground, the output may oscillate in a random manner. Such an oscillation was noted several minutes after data recovery following the incident. It should be noted that with a short-circuit in the quantity gaging system inside the tank, the maximum current that could be drawn is 15 milliamperes.

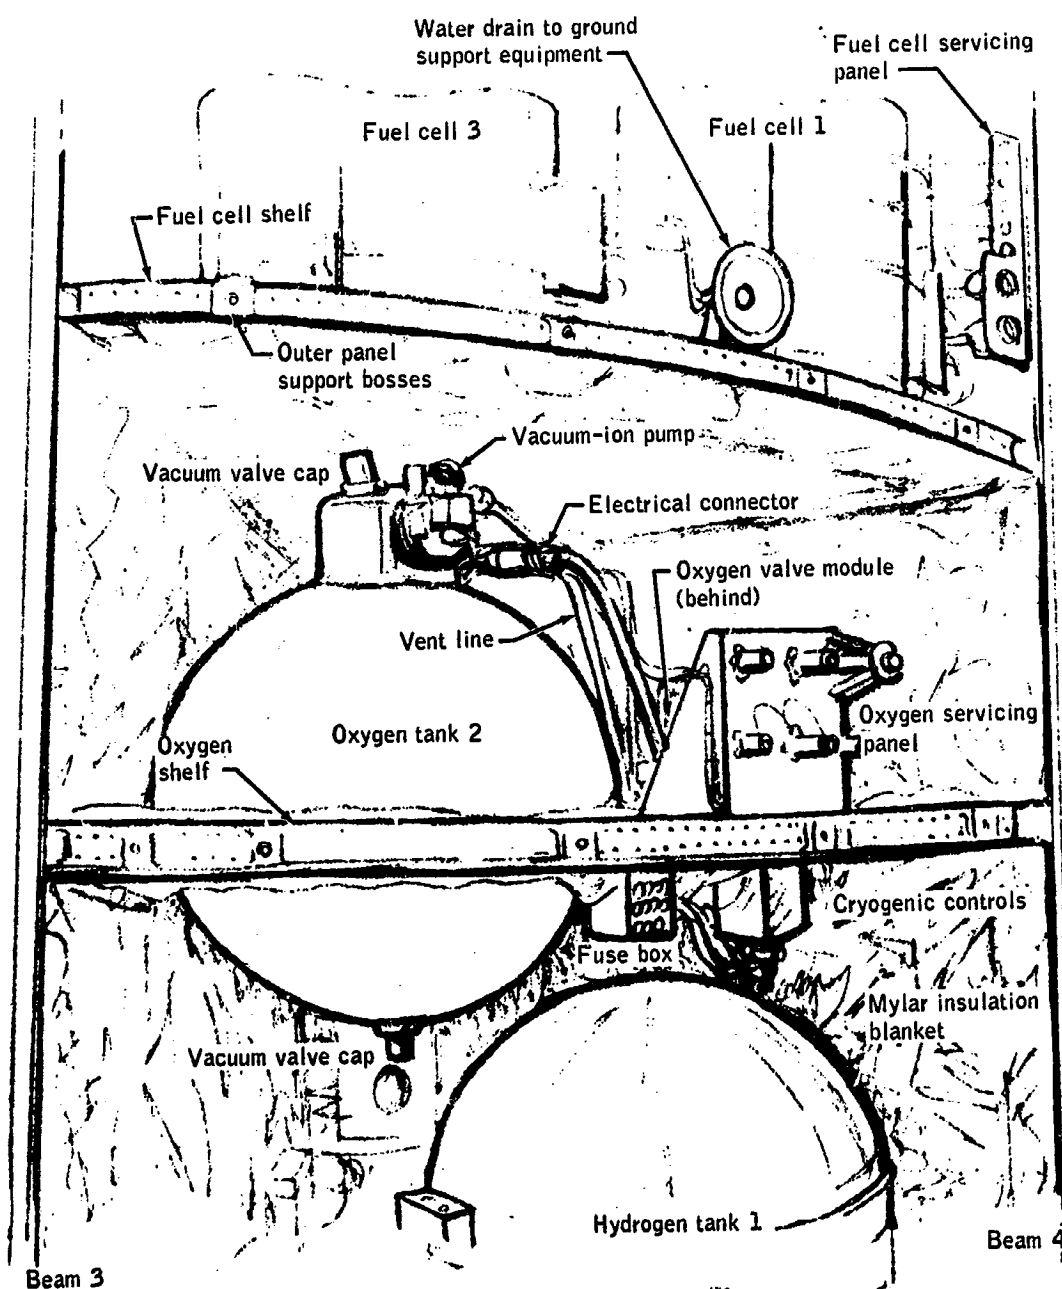
Figure 4-17.- Bay 4 closeout photography.

- a. The fuel cells (1 and 3) are tipped slightly forward (outboard) so the rear of the fuel cell shelf apparently was raised.
- b. The insulation blanket was removed from the underside of the fuel cell shelf near radial beam 3 and above oxygen tank 2, since the color of the bare shelf is visible.
- c. Mylar and Kapton insulation blown, torn, and/or partially burned free from its initial fastening, now congest some areas of the bay and extend outside the service module from several places along the edges of shelves and beams.
- d. The oxygen tank 2 appears to be present and discolored. Because of the blackness of the non-illuminated remaining interior, aluminized Mylar and Kapton, and the discoloration of the oxygen tank 2, the blend

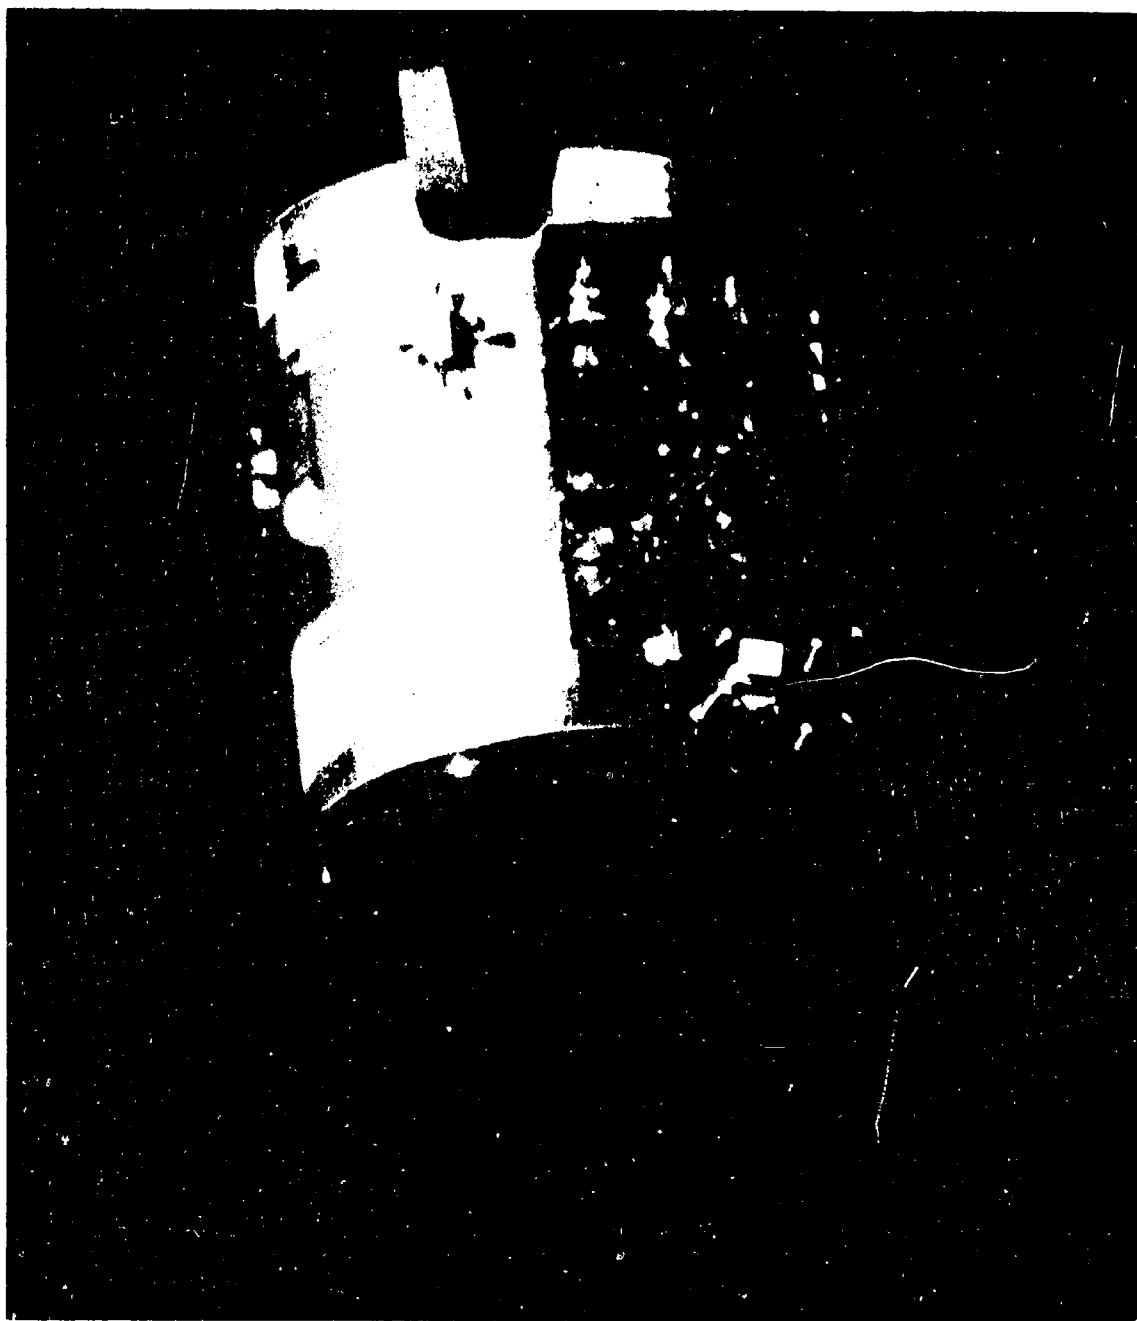
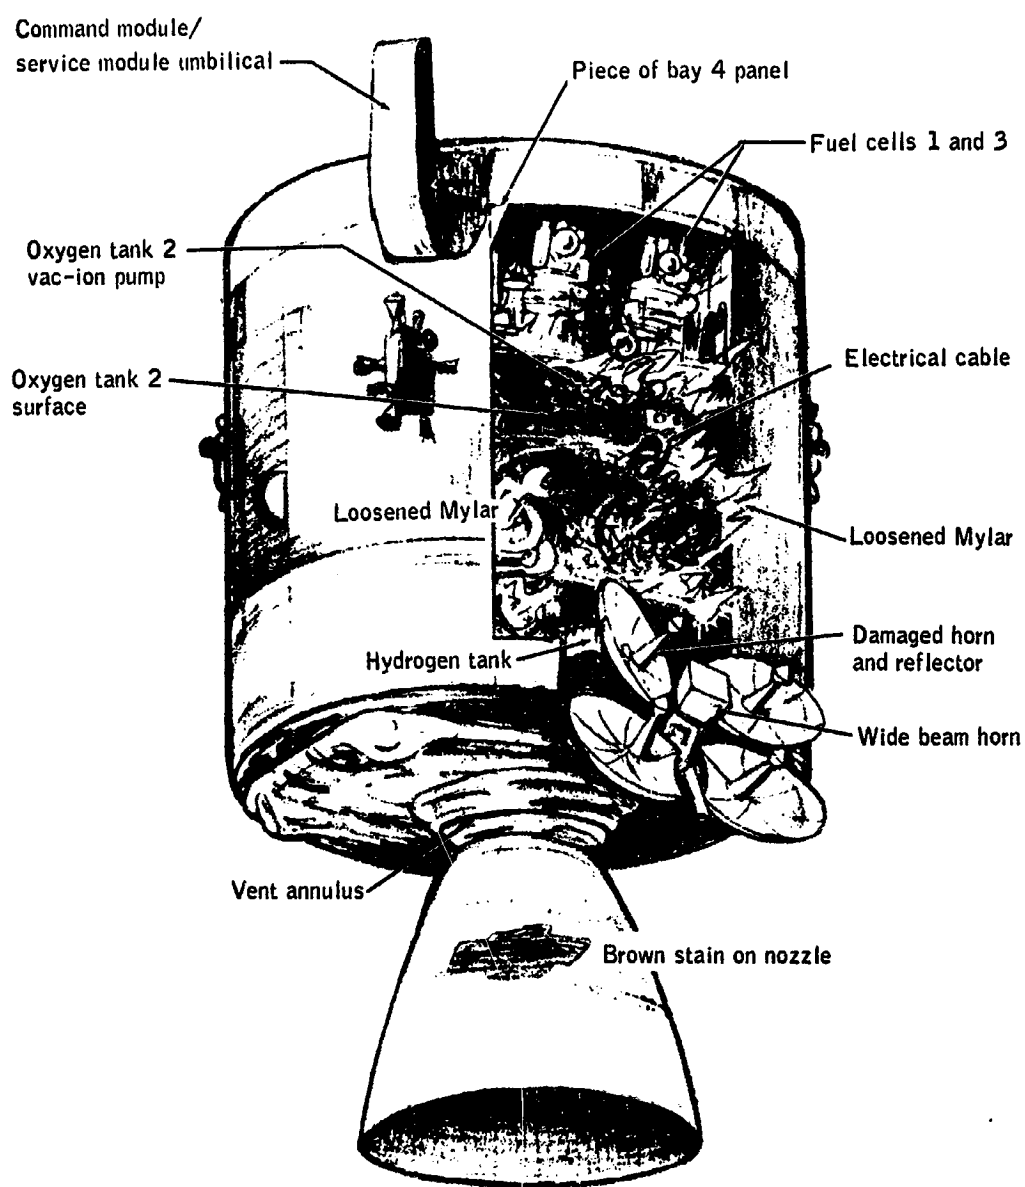
Figure 4-18.- 70-mm color film frame 8464.

h. One of the four reflectors and feeder horns for the high-gain antenna was damaged. The attitude of the antenna, with the damaged reflector nearest the service module, had changed since the incident because the gimbals are free to rotate whenever the power is turned off.

i. The oxygen service panel appeared in its normal position, but with considerable loosened Mylar and Kapton in the area.

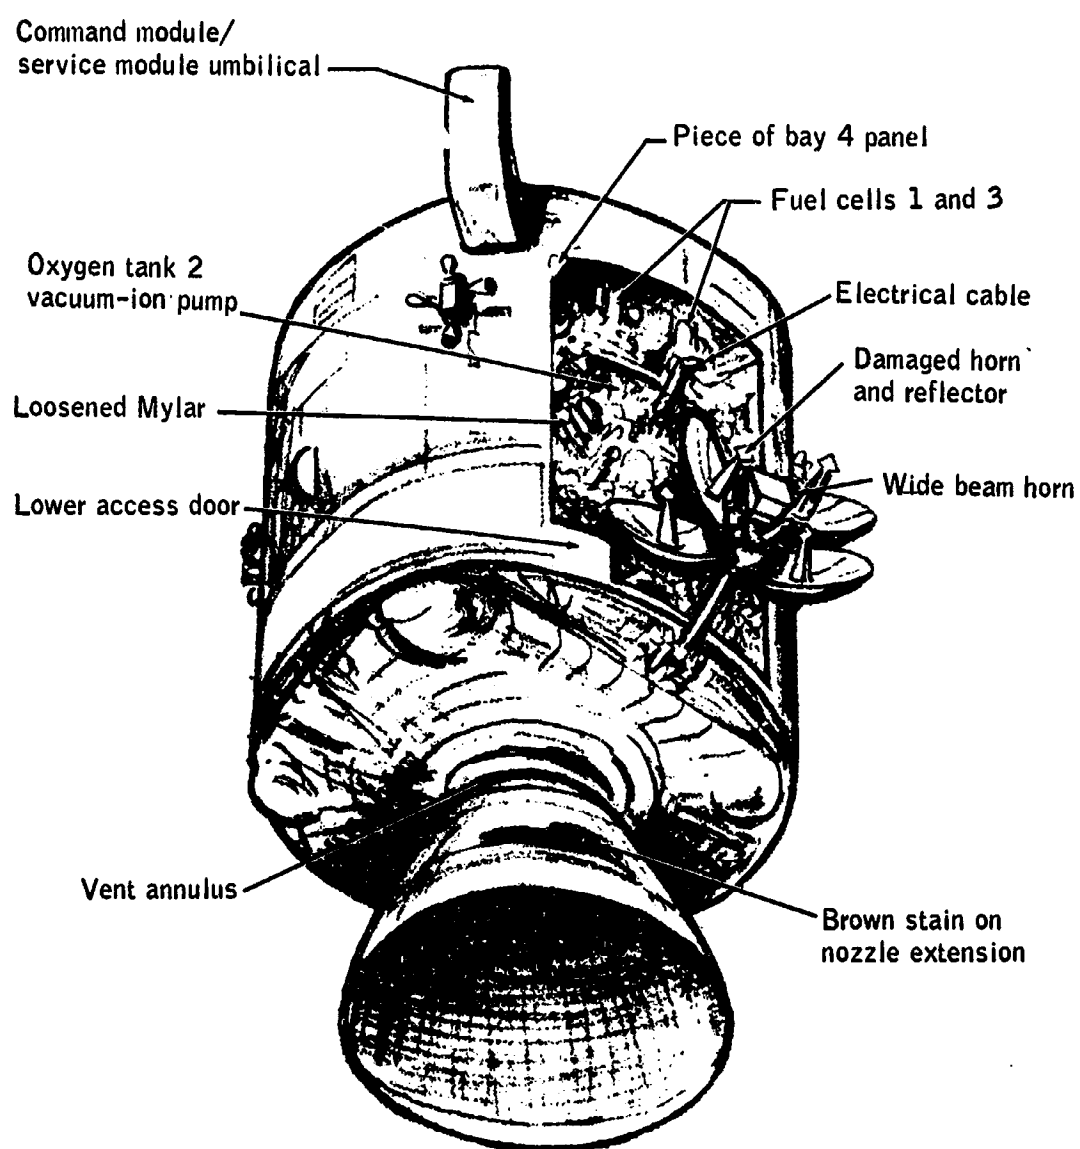
Figure 4-19.- 70-mm black and white film frame 8501.

j. A brown stain was observed on the outside surface of the service propulsion system engine nozzle extension, near the plus Z axis, and in line with the vent path from the vent annulus around the nozzle.

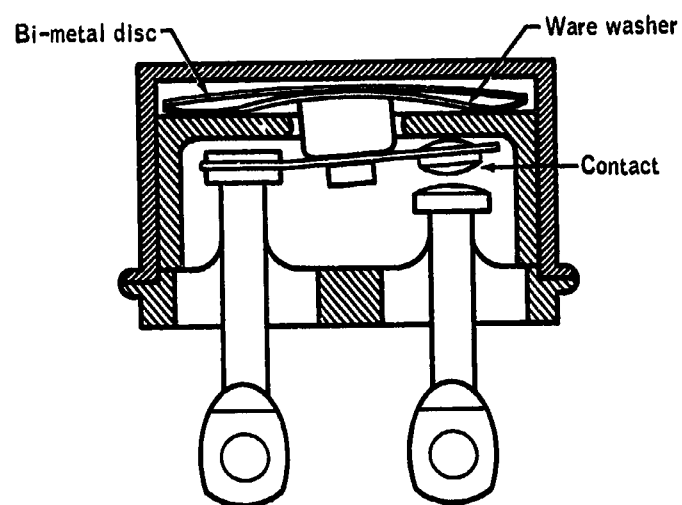
Figure 5-5.- Heater thermal switch.

The thermal switches, which normally open at about 80° F, show no sign of operation from the heater voltage data. Inflight, these switches have not operated due to the temperatures in the tank. Further, the switches in the past have not operated under a load on the ground, and they were not designed or tested for this condition.

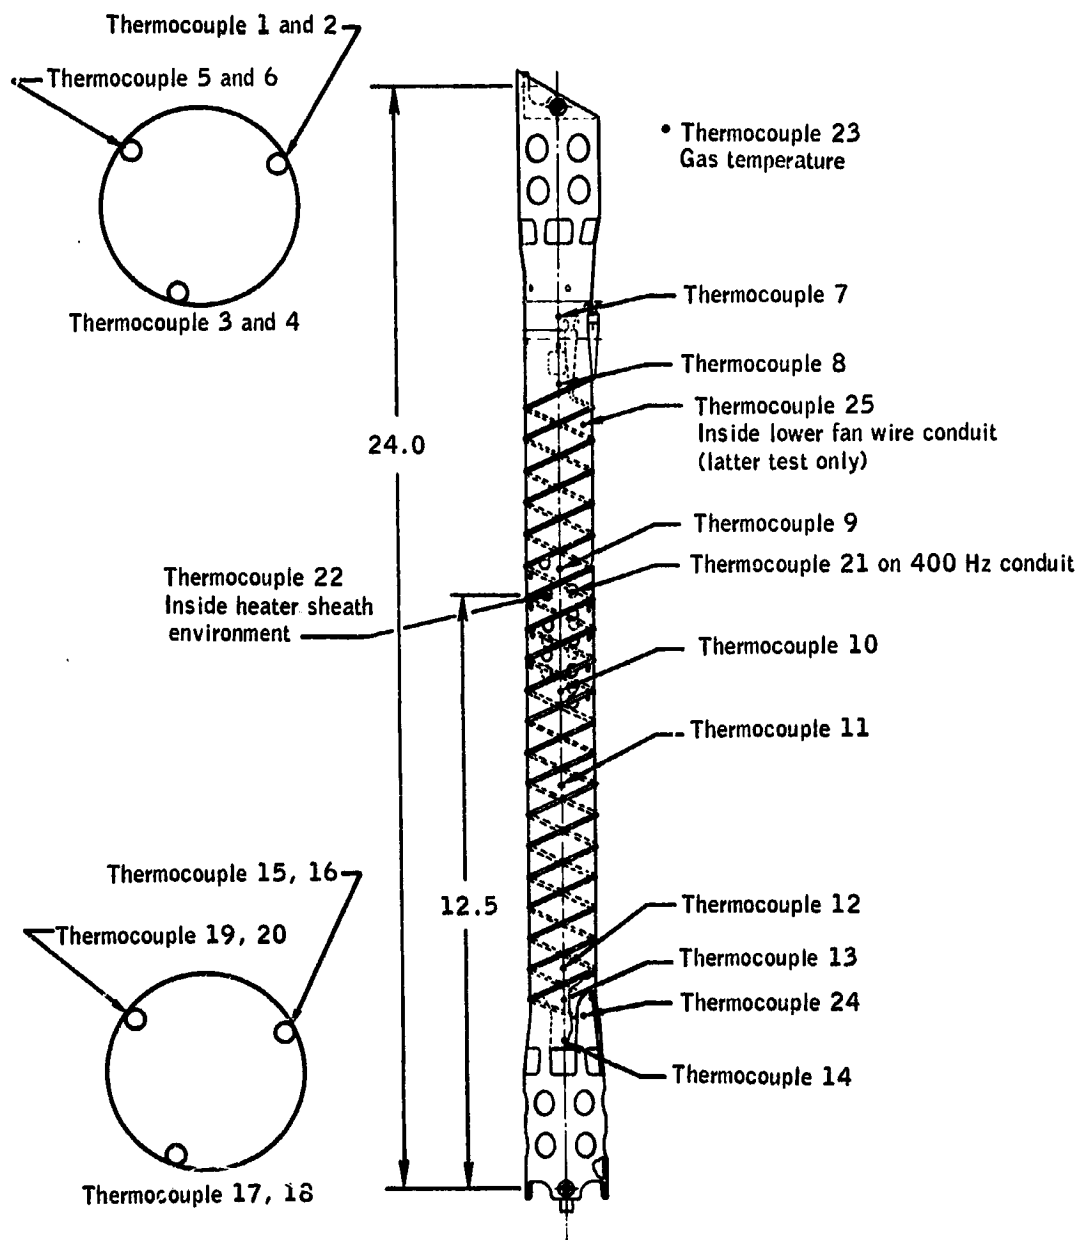
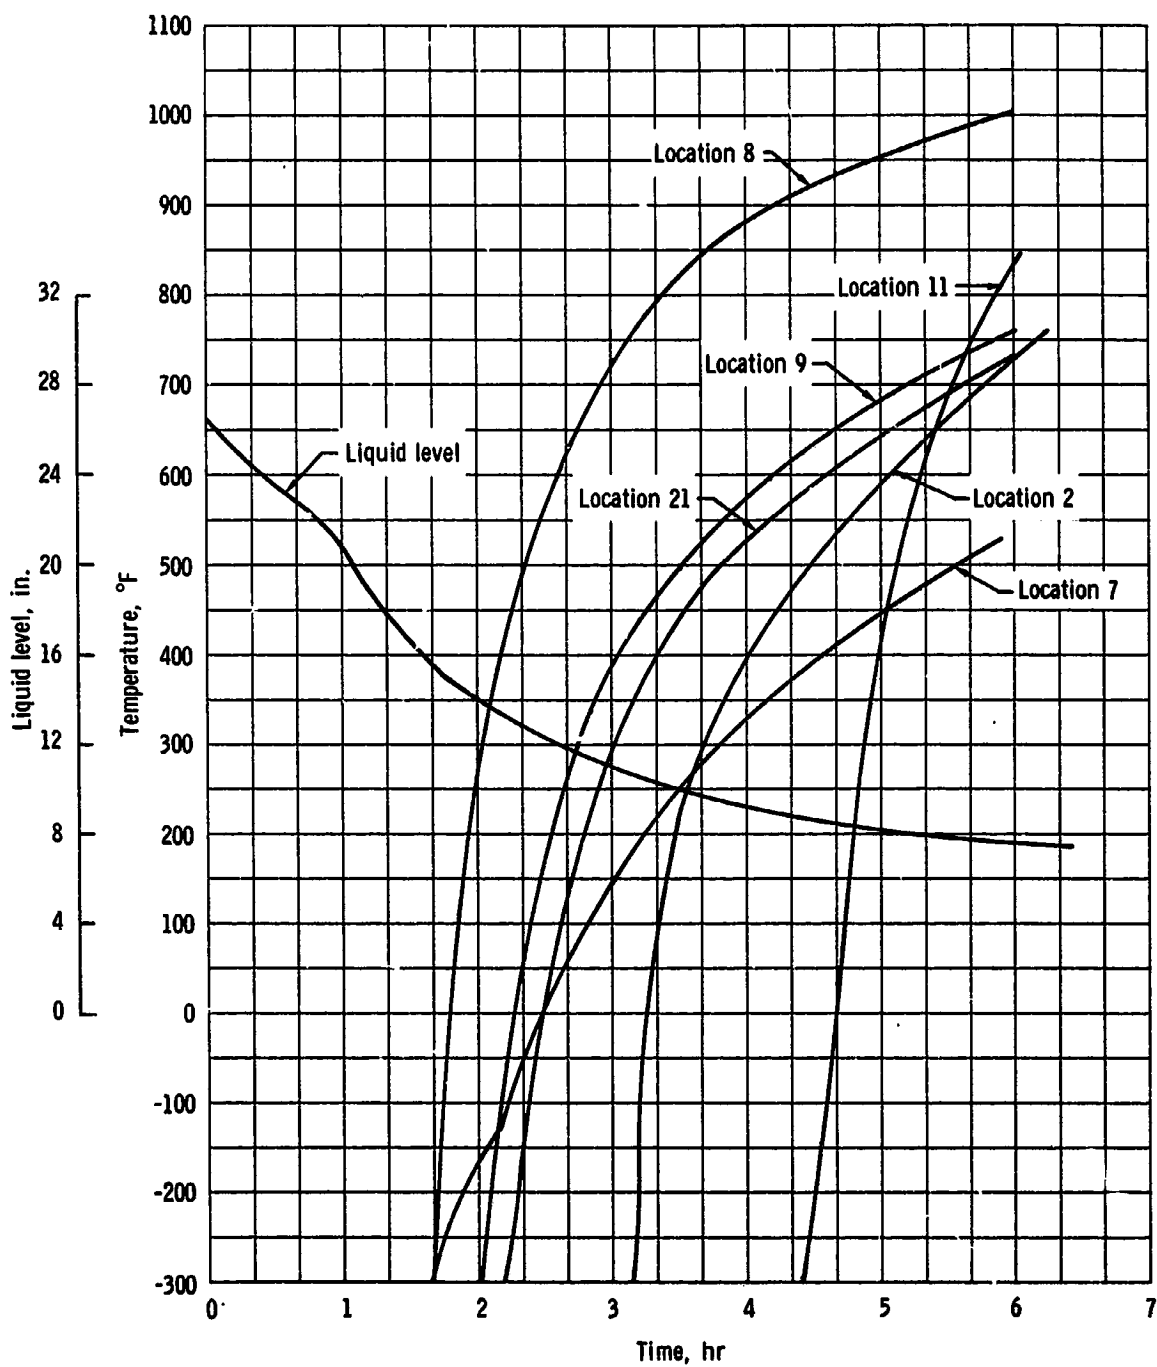
Figure 5-7. - Heater/fan typical test results.

Wiring can be damaged within a couple of hours, with the heaters being "on" continuously as evidenced by the temperature on the heater assembly (figs. 5-6 and 5-7).
